**Monhegan
Museum of
Art & History**

White Paper

Creating a Sustainable Preservation Environment

Project Director: Jennifer Pye
Monhegan Historical & Cultural Museum Association
February 15, 2019

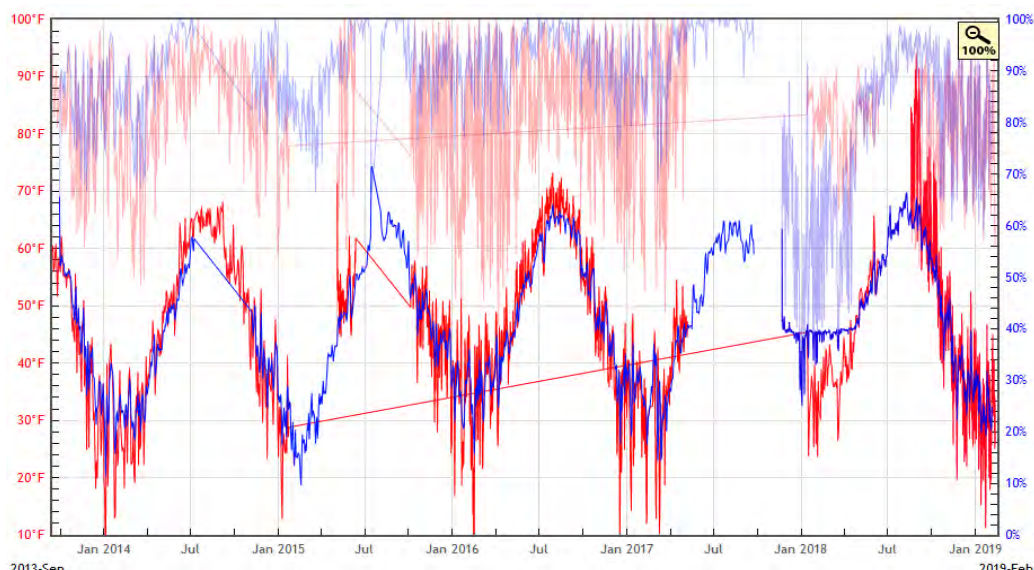
During the winter of 2017-2018 the addition of heat to the basement kept the temperature at a minimum of 45 degrees and significantly reduced the RH in the space. It is our intention to continue to heat this space; however the underground tubing that supplies the heated water/glycol to this building was punctured during the installation of a tent for the celebration of the museum's 50th anniversary during the summer of 2018. Parts to repair the puncture are on hand, but the necessary tool is backordered. We anticipate that the pipe will be repaired before the end of March 2019.

The summer of 2018 brought unprecedented heat as can be seen by the red line on the graph. This makes it difficult to draw conclusions about the ultimate success of the project without further data. Environmental monitors remain in place, and conditions will continue to be observed.

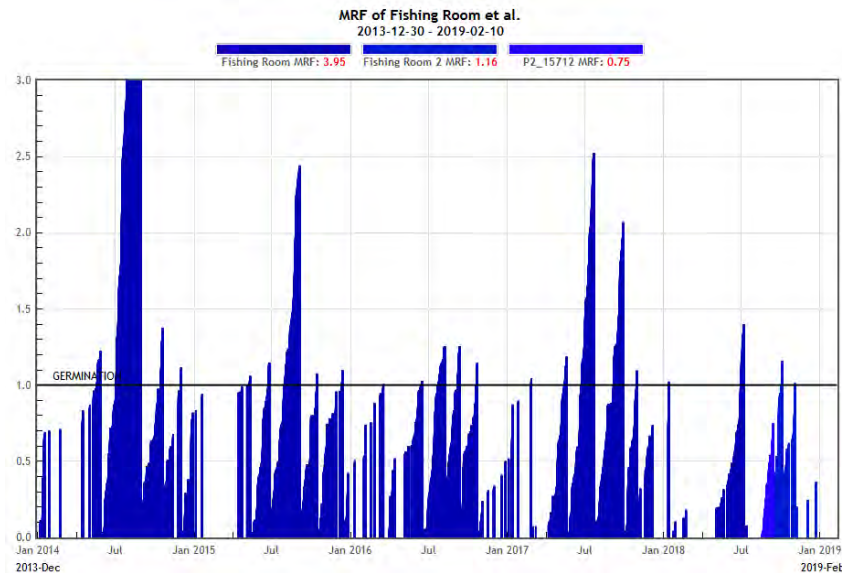
Improvements to the conditions in the basement translate into lower RH on the upper floors. This graph shows how the potential for mold growth in the Fishing Room display space on the first floor has continuously diminished.

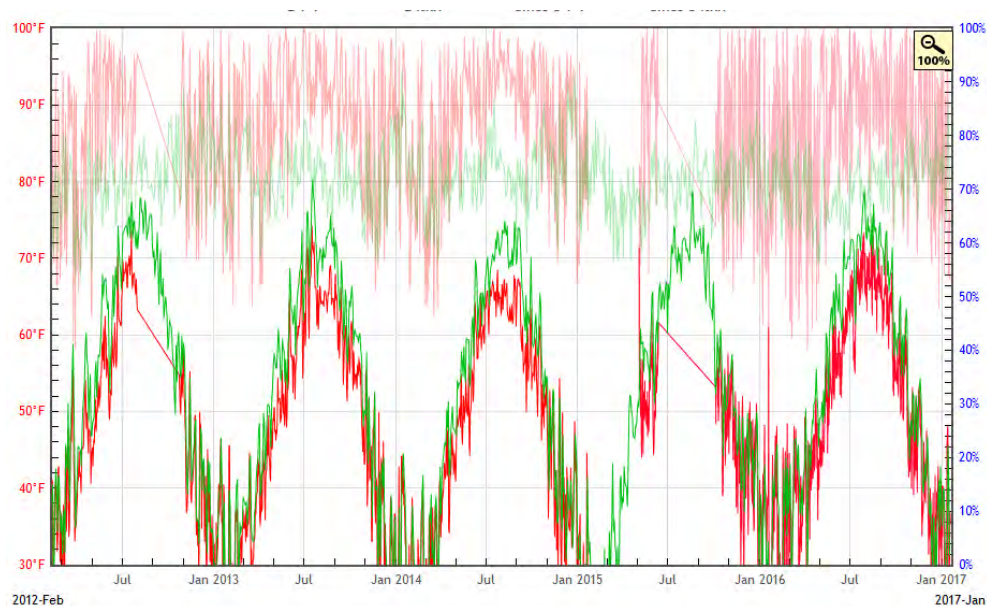
The following graph shows the temperature and relative humidity on the second floor of the Keeper's House (green) compared to the exterior conditions (red). Window work completed during the spring of 2017 allowed for windows on the second floor to be opened for ventilation. This resulted in the interior temperature more closely mirroring that of the exterior- rather than being several degrees higher. This also shows a modest decrease in RH.

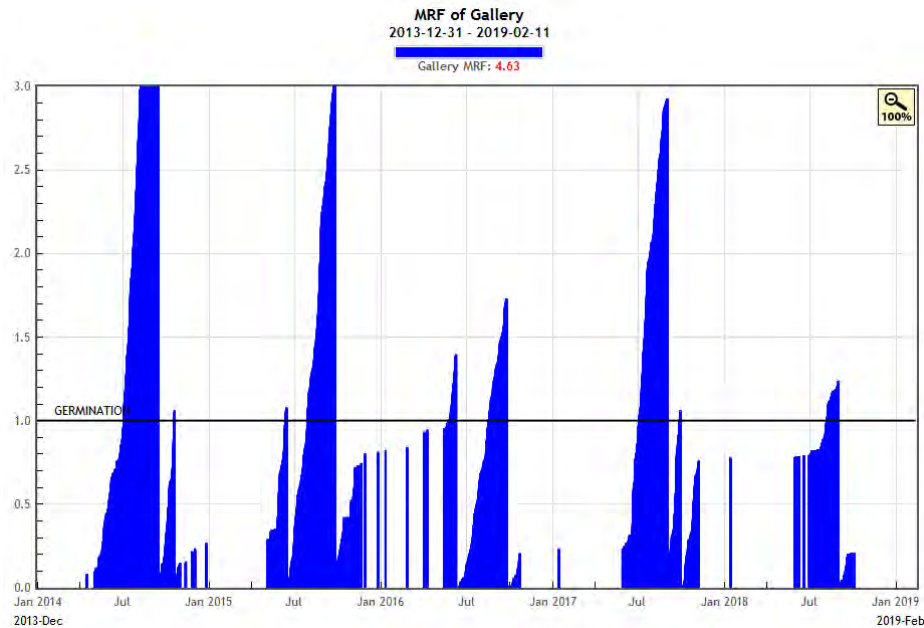
The RH of the Gallery during the summer of 2018 was reduced to an average of about 65% from the past level of an average of 80%, and the mold risk factor was significantly lessened. We anticipate that the risk will be eliminated in the future as the small risk indicated in 2018 was as a result of equipment failure at MPPD.

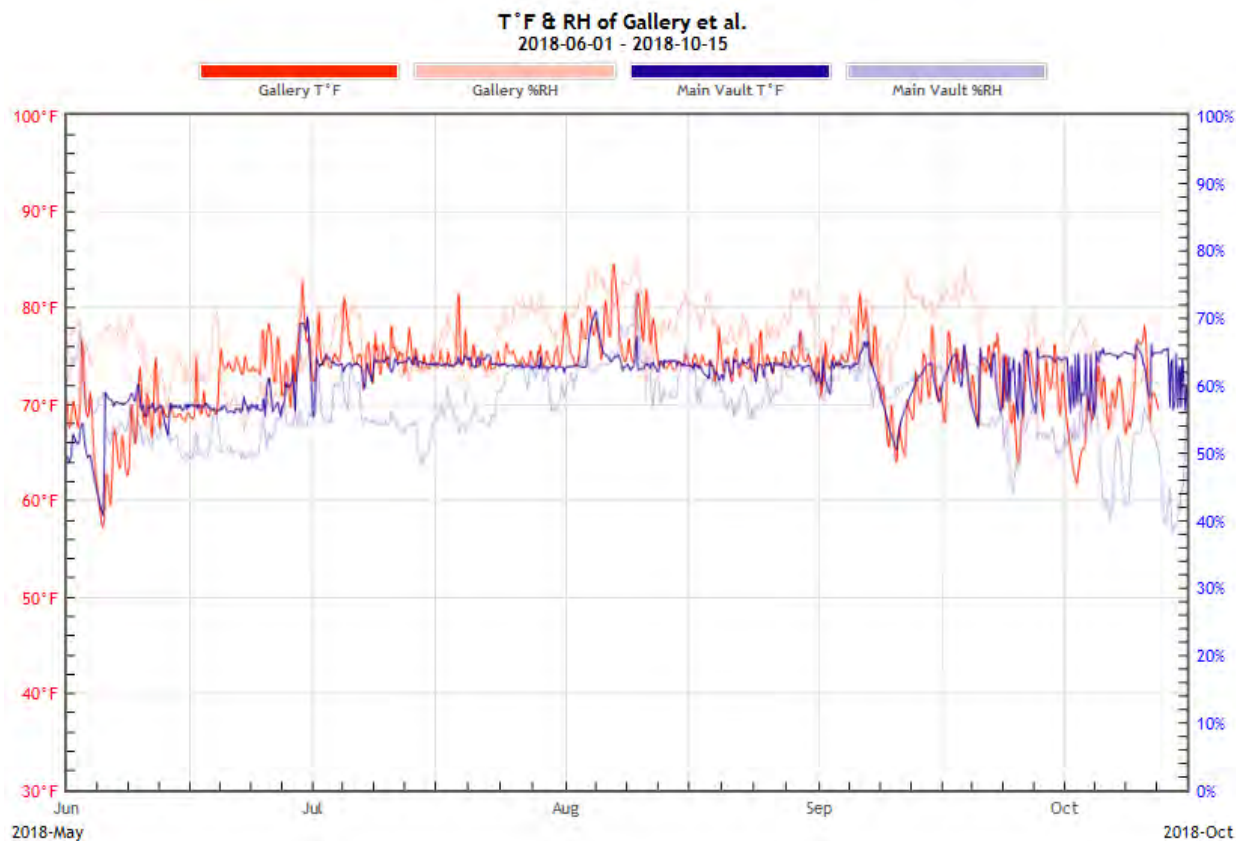
The following graph shows the temperature and RH of both the Gallery and the purpose- built Main Vault over the summer of 2018. Temperature and humidity were a significant concern in the heavily visited gallery, but the Main Vault maintained temperature and RH well despite the shutdowns, which bodes well for more extensive experimentation with operation for energy-reduction in the future..

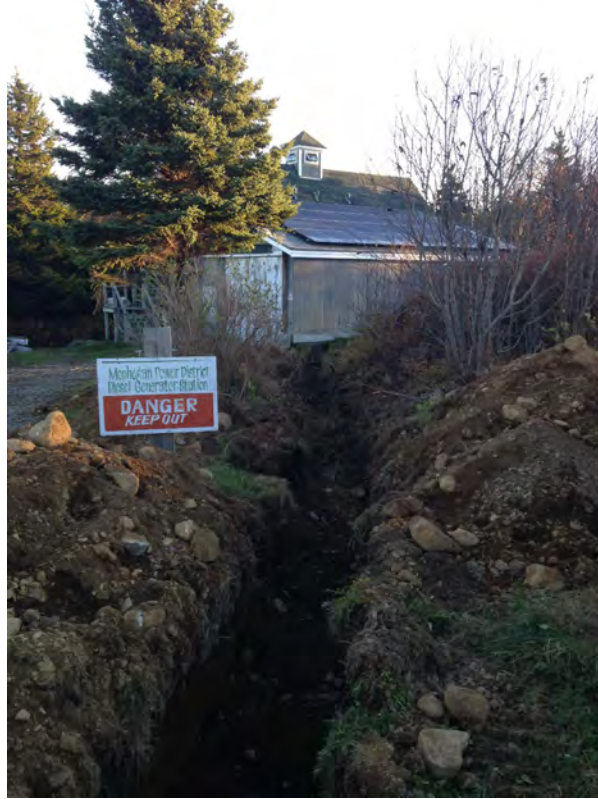
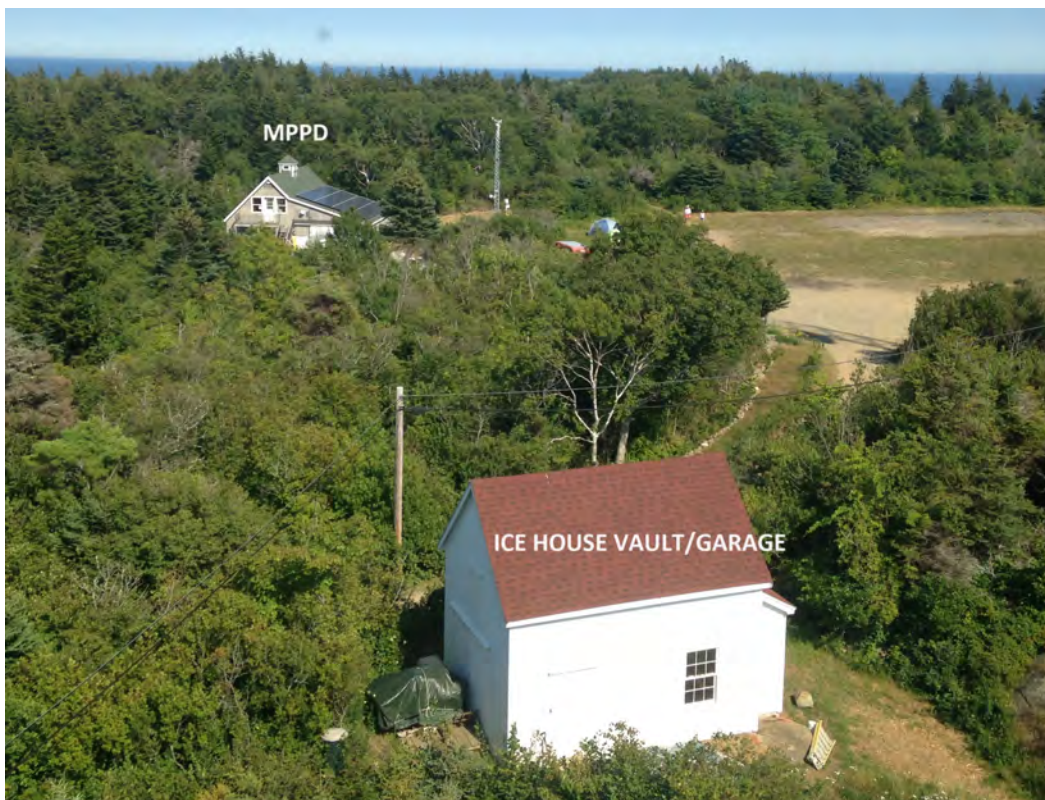
Piping Images from MPPD to Museum

3 foot deep trench from MPPD to the museum for heat recovery piping.

Distance of MPPD from Museum. Trench runs in a reverse C-shape along the edge of the road.

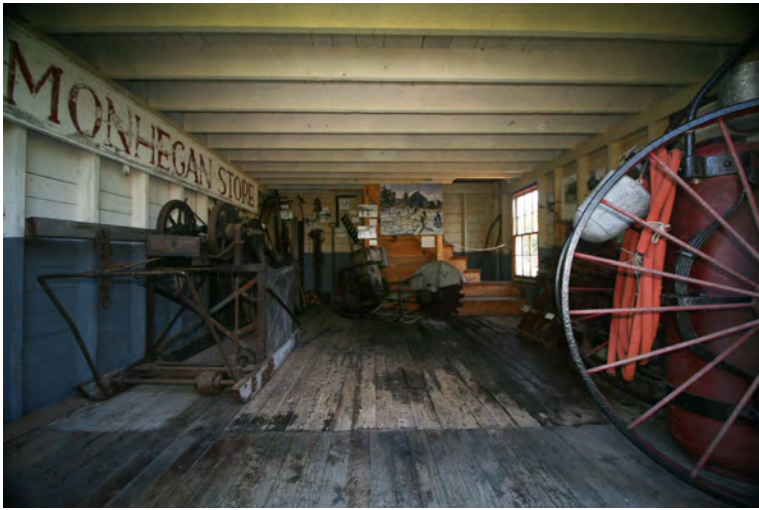
1. Ice Cutting exhibit prior to modification of the space.

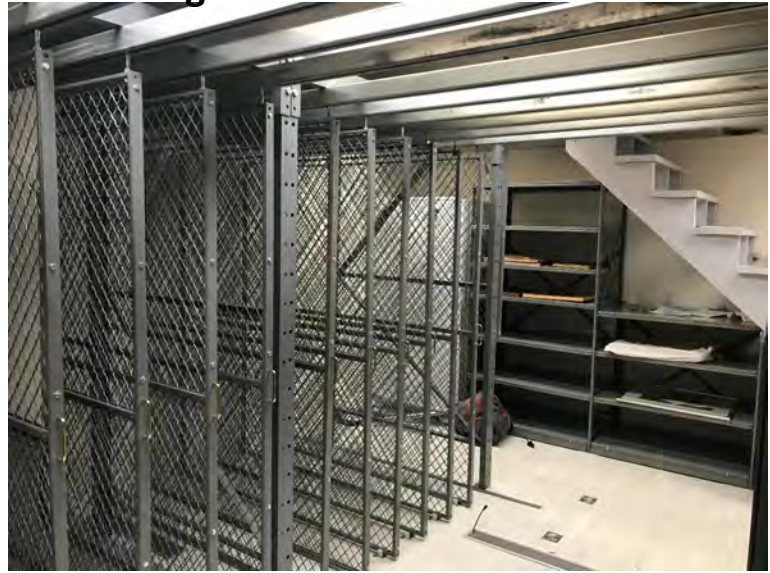
8. Artwork screens, shelving, and freezer installed.

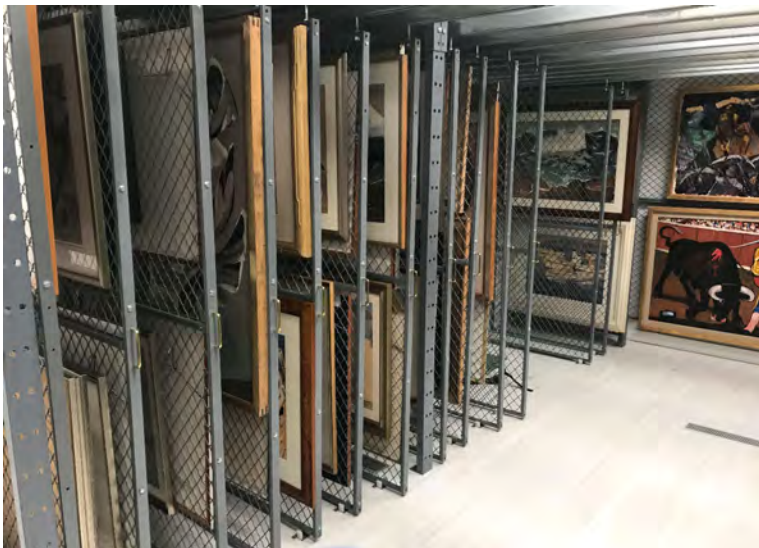
9. Collections housed in new space.

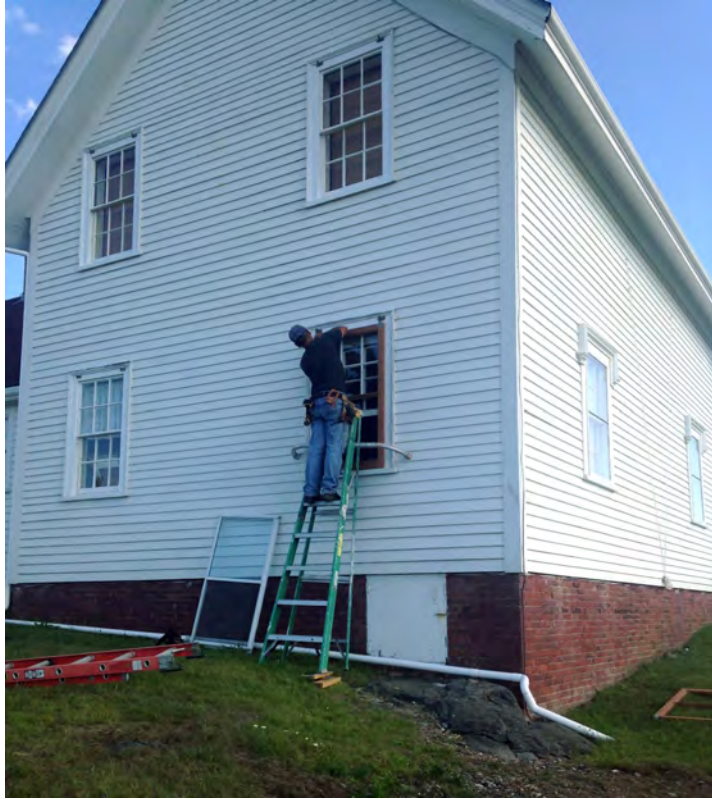
Window test fit.

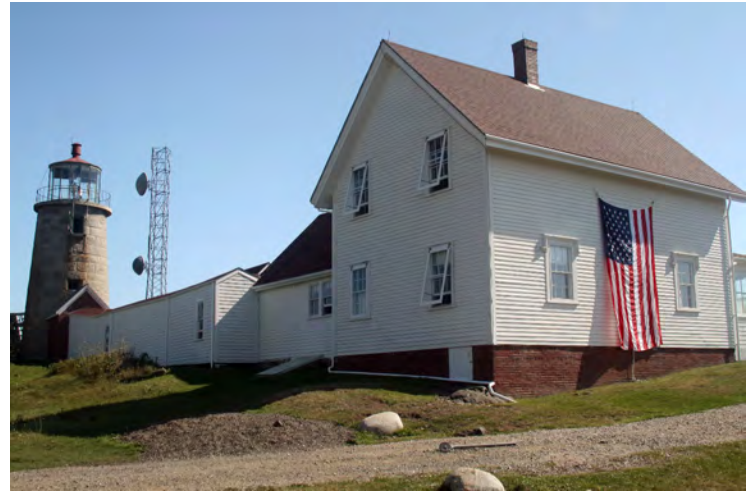
Storm windows installed

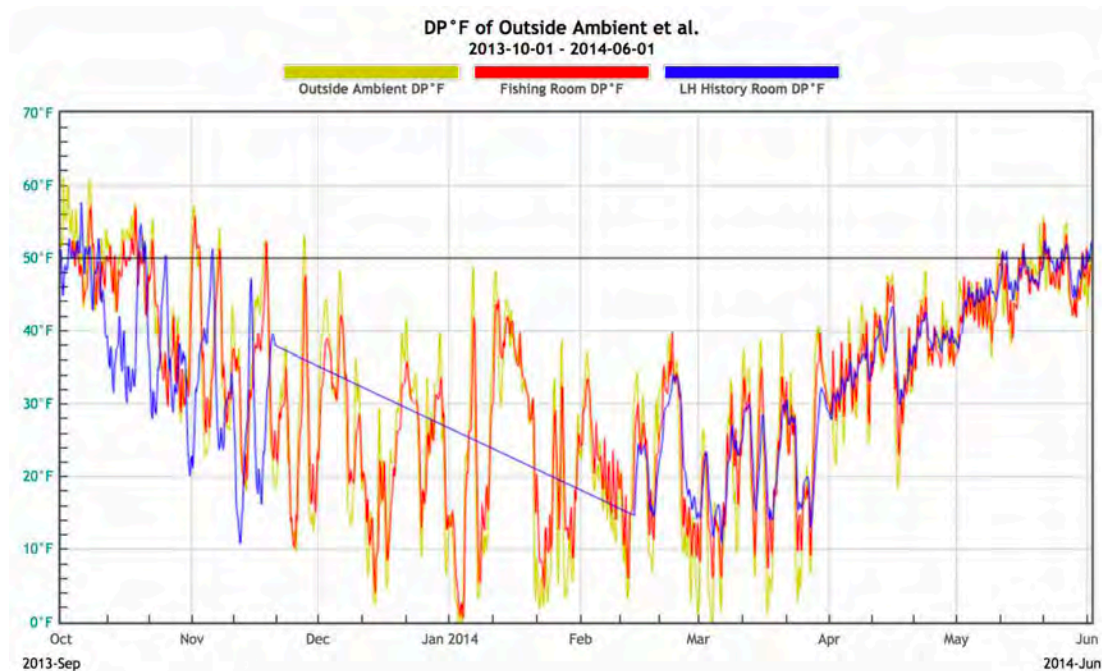
*Keeper's House Dew Point, 2013-2014. Note that interior dew points (blue and red) tracked with outdoors (yellow) in fall 2013. After installation of door panels in the LH History Room, the space no longer responded to the full exterior dew point changes in winter/spring 2014. *An incorrect datalogger time code in the fall of 2013 shifted data points to ~two weeks earlier than actual recordings.*

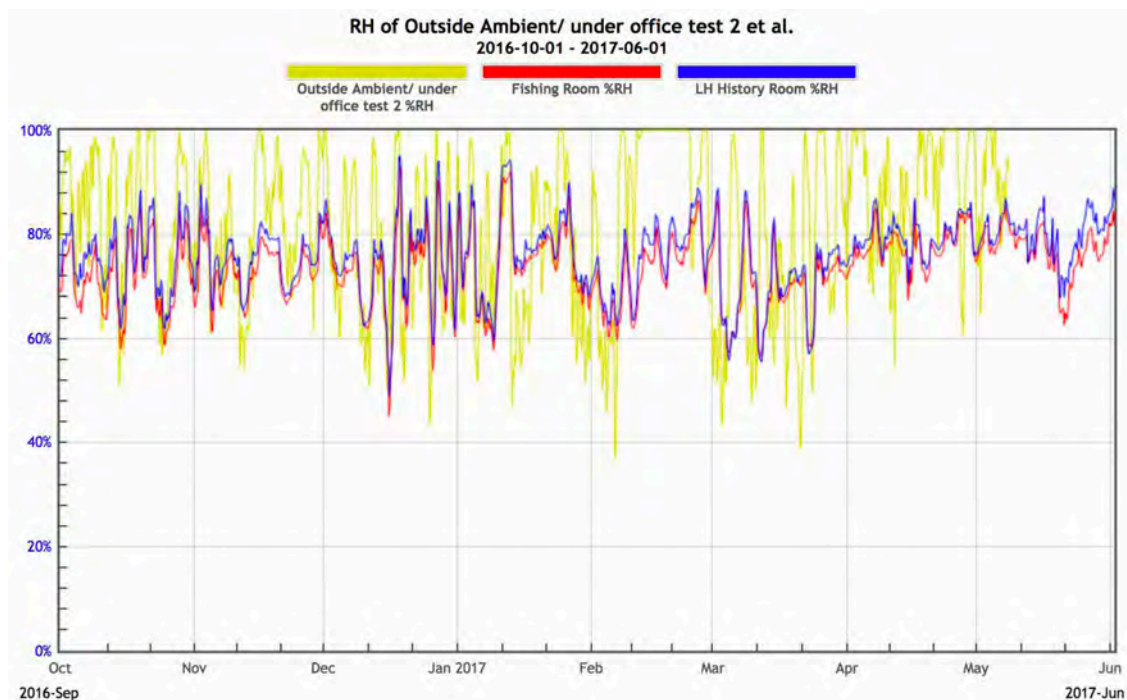
Keeper's House RH Graph, 2016-2017. Note the muted RH plot compared to outdoor conditions, primarily as a result of consistently lower dew points.

During the winter of 2016/2017, when a number of these improvements were underway, the interior dew point during the winter months was successfully muted compared to outdoor conditions, which resulted in RH conditions that, while still high enough to cause concern for mold germination, were consistently lower than the high outdoor extremes. The completion of most of the structural repairs between 2017-2018, combined with the head added to the basement in fall 2017, resulted in no mold growth in the first floor of the Keeper's House in the spring of 2018.

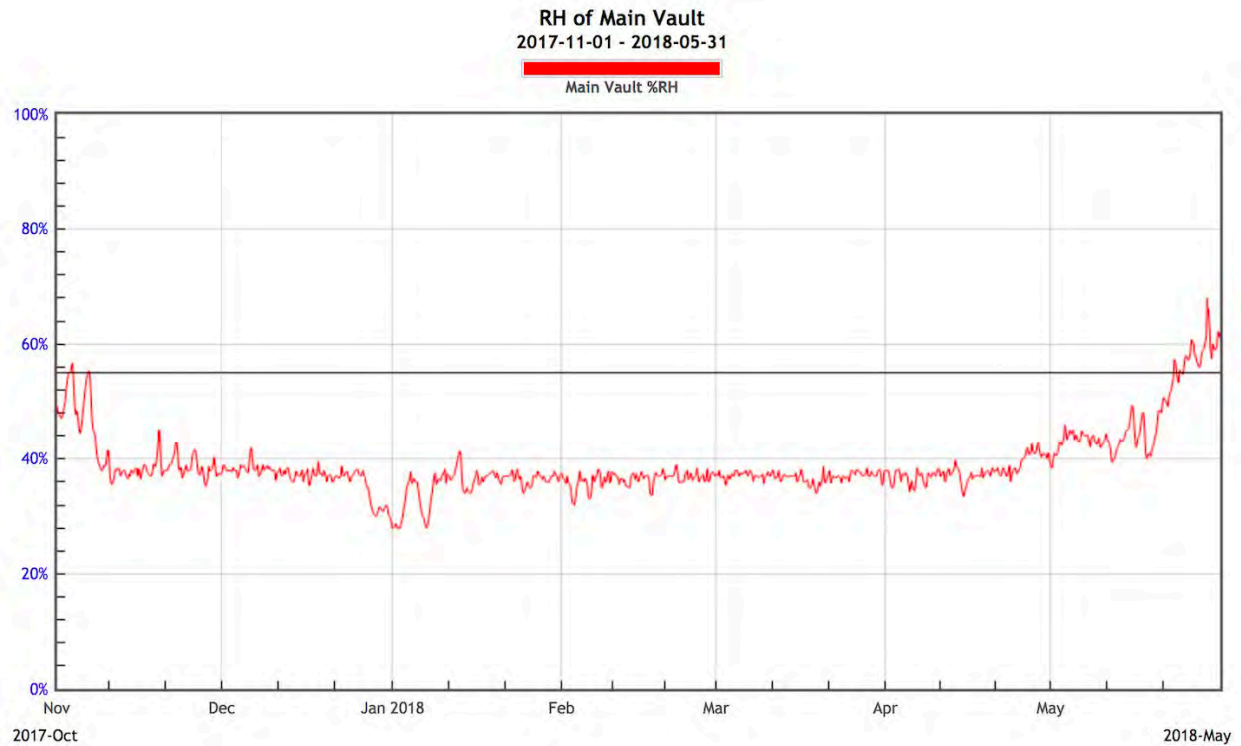
The programming for winter operation, and the behavior of the interior environment, shows a standard humidistatic control (commonly known as “conservation heating”). The basic logic is that the system is controlled to maintain a specific RH condition by controlling the temperature in the space – when the RH begin to rise, the temperature is increased to bring it down, while when RH is steady or begins to drop, the space is allowed to cool down in order to raise the RH. The result, shown in the graphs below, is a very steady RH condition in the space, and temperatures that fluctuate regularly (and significantly).

Main Vault, RH Graph - Winter 2017-2018. Note flatline control of RH condition.

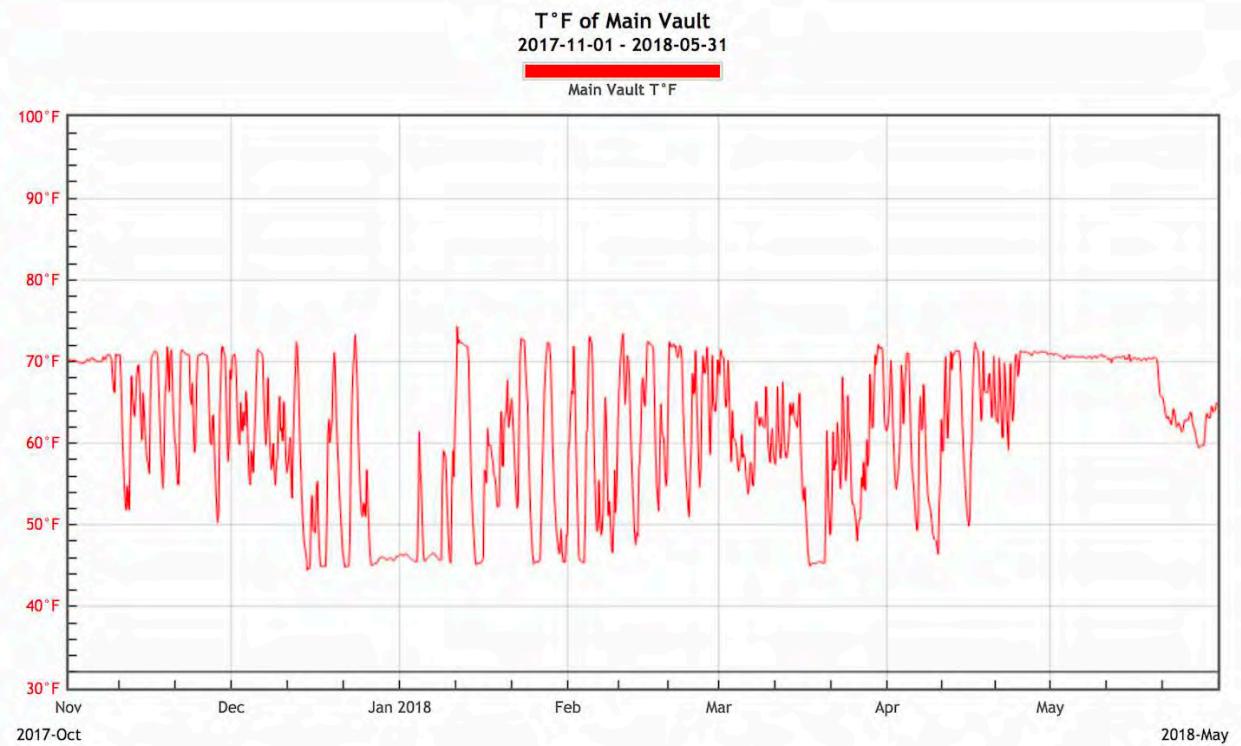
Main Vault, T Graph - Winter 2017-2018. Note fluctuation in order to maintain the above flatline RH condition.

While humidistatic control is appropriate in various settings – most commonly when the goal is to avoid mold germination conditions or to maintain steady RH conditions to protect against mechanical damage – the primary winter concern for the Main Vault is to keep the temperature condition as low as possible (45F minimum) while keeping the RH conditions within an acceptable band (the seasonal 30-55% range). These conditions have the dual benefits of slowing the rate of chemical decay through cooler winter space temperatures, decreasing energy costs by minimizing heating, while still maintaining a safe RH band for protecting against mechanical damage.

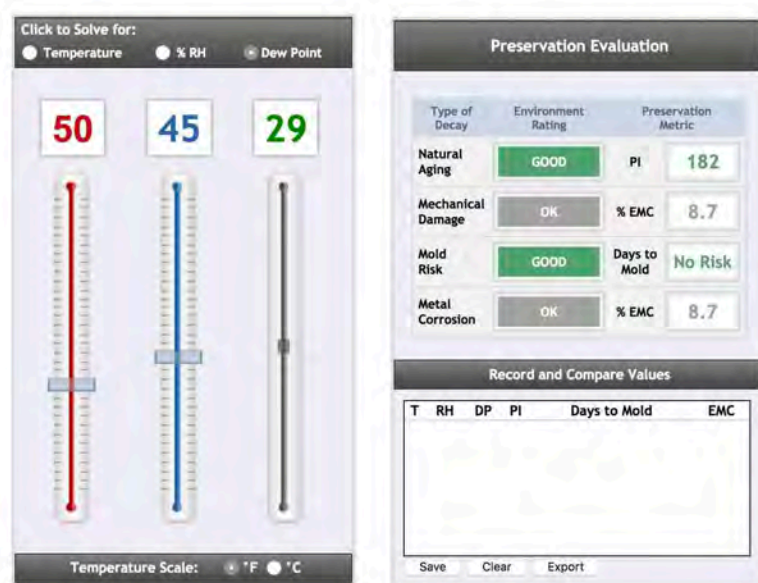
If the optimized control can allow the space to drift toward 45-50F more consistently, the winter TWPI for the Main Vault should be able to approach TWPIs of 140 or better – a significant improvement over previous conditions – with reduced energy consumption. Outdoor conditions between January and April 2018 were steadily below 50F, and the illustration at right shows an example preservation quality if 50F and 45% RH were maintained in the Main Vault during those months.

Dew Point Calculator (DPCalc) illustration of potential preservation index (182) at a 50F/45% RH condition. This condition is representative of an average winter condition that should be achievable with the new system and controls.

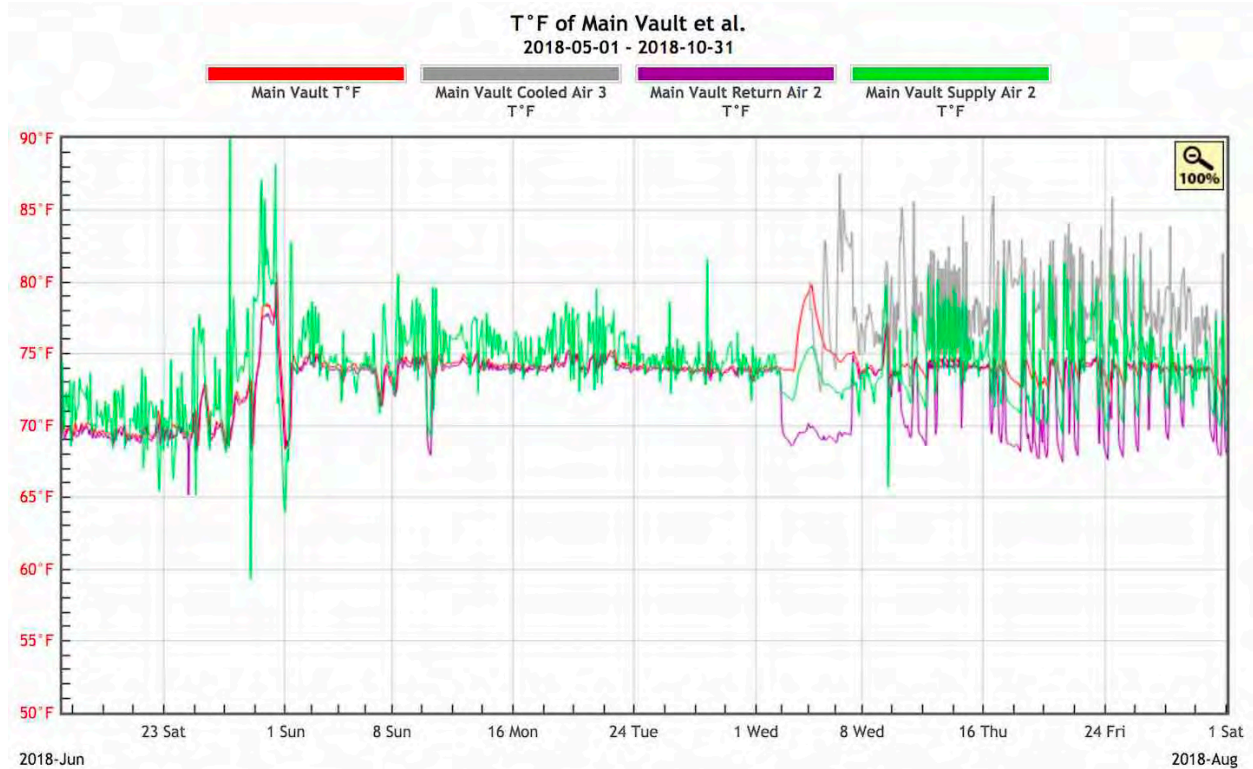
Space temperatures during the summer 2018 season ran slightly higher than the originally intended 70F condition, which is likely simply the result of a higher set point. Supply and return air conditions from the system indicate very little load from the Main Vault itself – return air comes back at the same condition as the room, while the supply air is, surprisingly, somewhat warmer (1-5 degrees F on average), actually appearing to be heating. That warmer supply air condition is most likely due to the power plant/chiller issues (ie, there simply was not chilled water available to create a cooler condition). Less likely is the possibility that the apparent 75F set point was actually high enough that the system minimized cooling in order to keep the temperature artificially higher compared to outdoors – though this is common in other buildings and environments, it is currently unclear whether the control logic would allow this to happen. A drop in temperature from the cooled air temperature to the supply air temperature indicates that the unit was not actively heating with hot water during this period.

Main Vault, T Graph - Summer 2018. Note minimal difference between supply air and return/space temperature. Though cooled air data is missing for much of the summer, the grey plot in August does show limited sensible cooling operation.

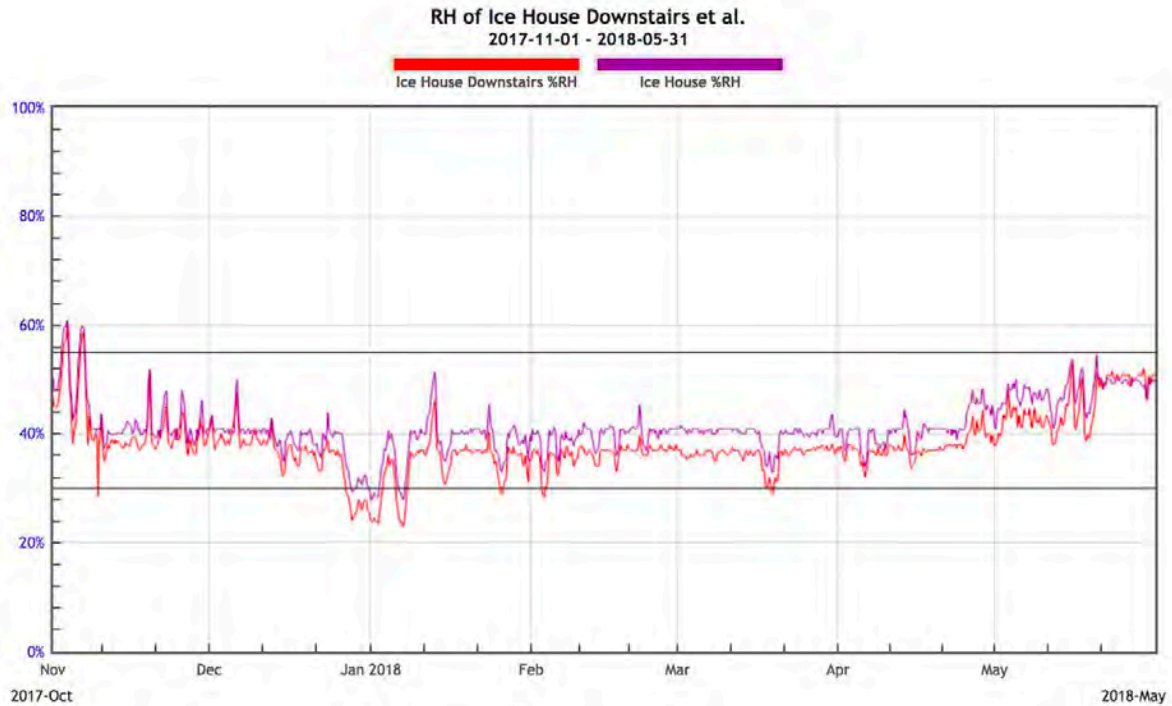
The programming for winter operation for the Ice House mechanical system is currently the same concept as the that in the Main Vault – humidistatic control based on achieving a specific space RH. Like the Main Vault, both floors of the Ice House show very steady RH conditions, with the lower floor (~36%) slightly lower than the upper floor condition (~40%). These RH differences are accompanied by corresponding differences in temperature operation. While neither RH condition is an issue from a preservation perspective, the team should check whether the difference between the floors is based on purposeful set point control, or if there is something else – control issue, sensor calibration, mechanical issue – influencing the performance. A difference in logger calibration is possible, but both loggers are showing the same dew point condition, which makes that possibility less likely. Like the Main Vault, the graphs show both the steady RH control as well as the regular fluctuation in temperature in order to control the RH.

Ice House, RH Graph - Winter 2017-2018. Note flatline control of RH condition.

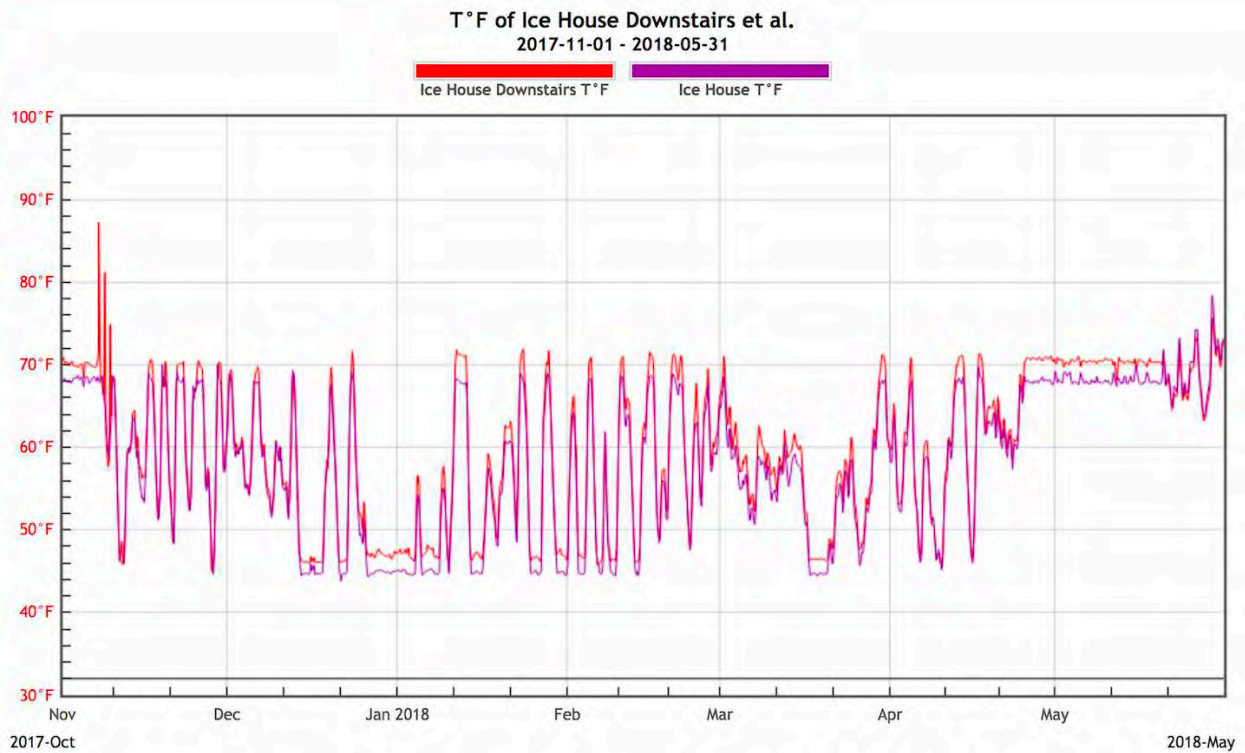
Ice House, T Graph - Winter 2017-2018. Note fluctuation in order to maintain the above flatline RH condition.

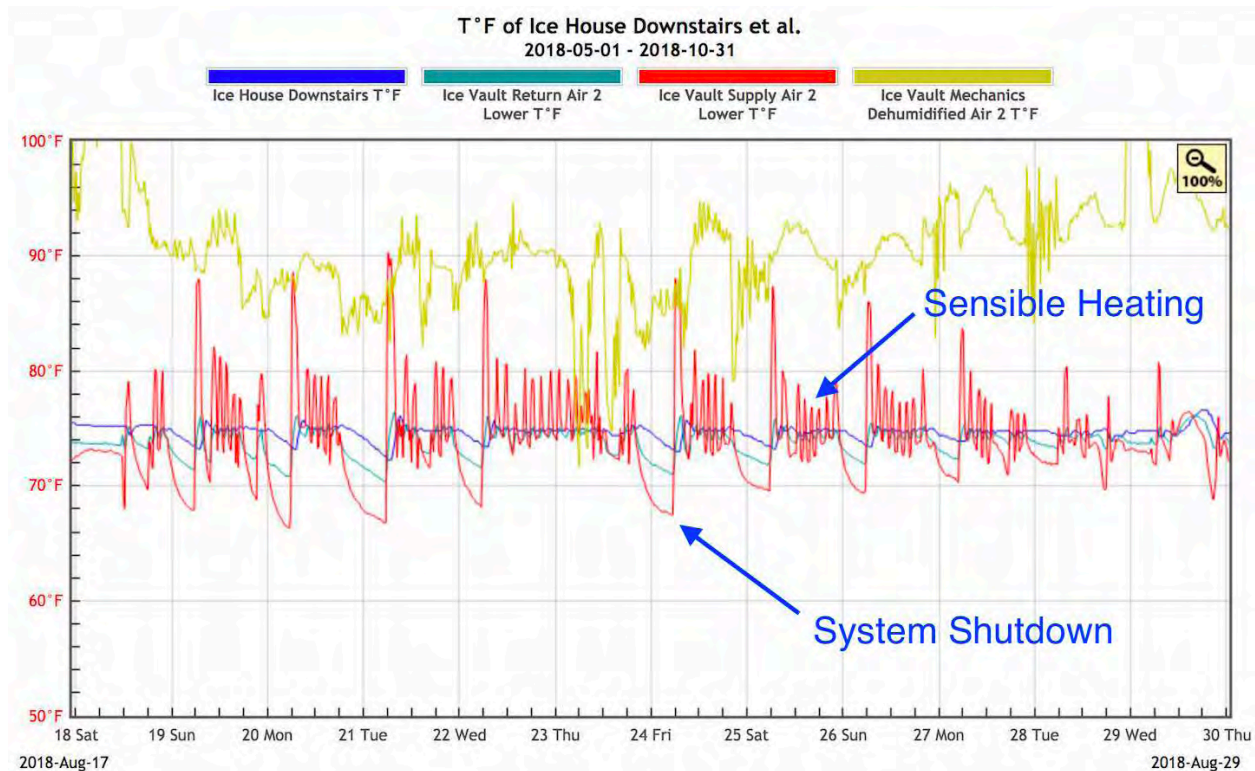
Ice House, T Graph, 1st Floor - August 2018. Note the shutdown behavior and the sensible heating in order to maintain the space temperature set point.

While the shutdowns appeared to be a short-lived event, the team should review available operational notes to determine whether this was a purposeful control, or if it was related to the power plant issues. Regardless of the cause, the data shows strong evidence that nightly shutdowns will be a viable strategy for energy-savings once the system control is finalized. The heating behavior never fully stopped, but is something that should be easily corrected by adjusting the logic that enables sensible heating.

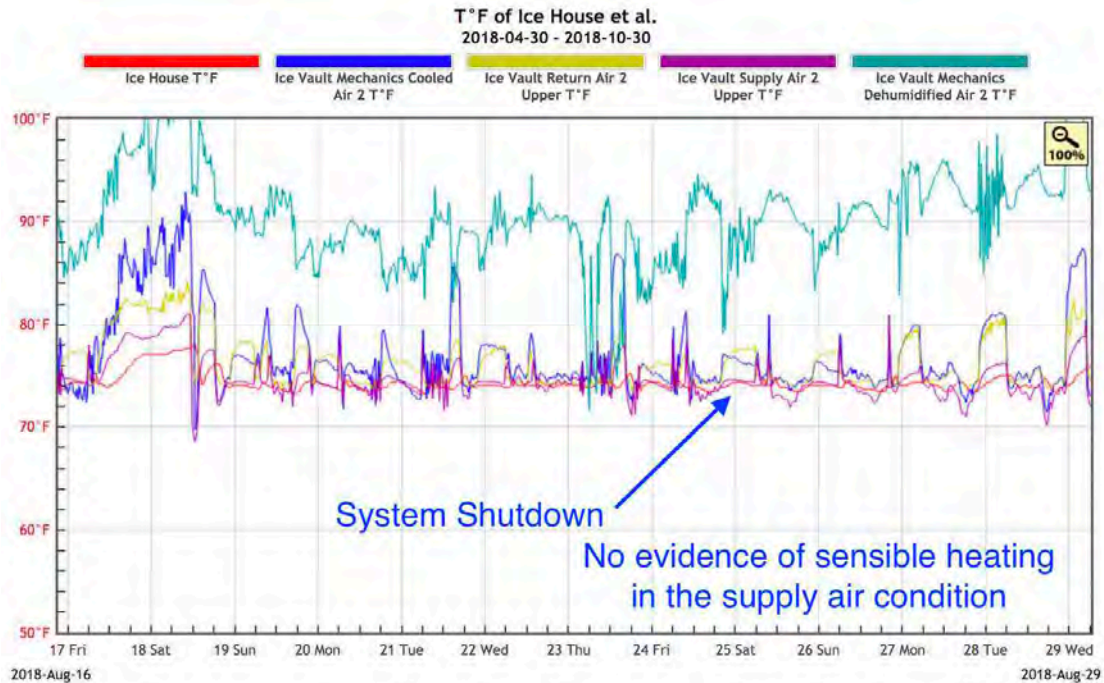
A review of the data for the upper floor also shows the shutdown influence, although far more muted than the response of the first floor, raising the question of whether sub-floor temperatures may be influencing the first floor, or if heat gain from the roof may keep the second floor from cooling down. Interestingly, the second floor data shows no indication of the sensible heating behavior that the first floor did, indicating that the space was less-prone to cooling (likely due to roof loads).

Ice House, T Graph, 2nd Floor - August 2018. Note the shutdown behavior (less impact on the space condition) and the lack of sensible heating compared to the 1st floor.

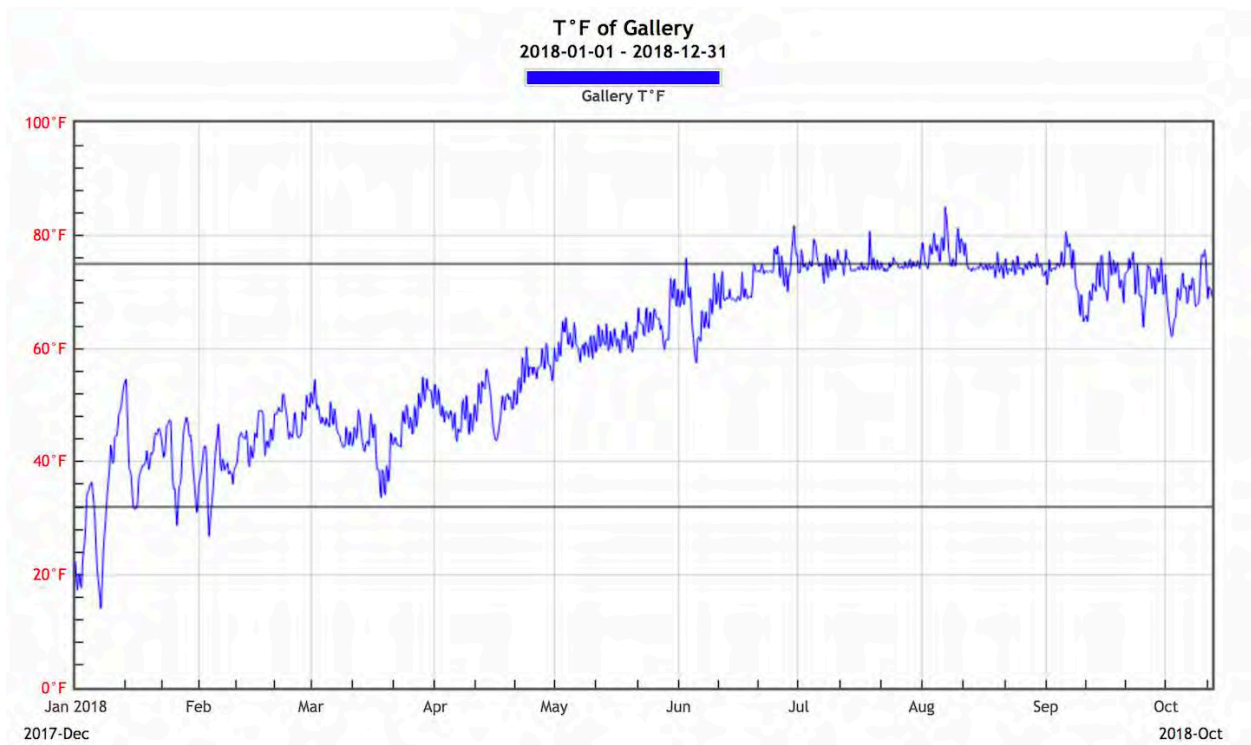
The summer of 2018 was the first time the Gallery had received active mechanical intervention – though heat was available during the winter of 2017-2018, the decision was made to leave the space unheated in order to reduce energy costs. Temperature data from summer 2018 indicates that the system was generally successful in maintaining a 75F set point, with periods of warmer temperatures (up to 80F) that may correspond with periods when the chillers were offline.

Gallery, T Graph - 2018. Limit lines are at 32F and 75F, note the unheated winter condition, and general set point maintenance in summer.

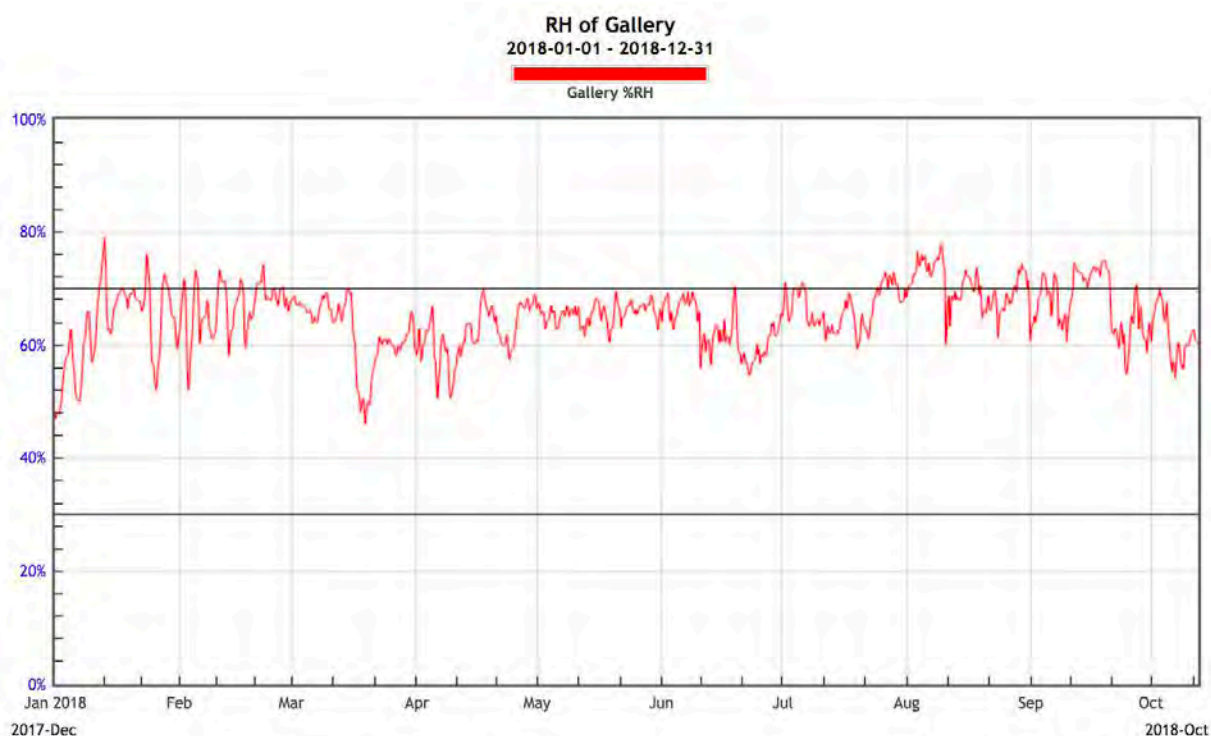
RH control, while better than in previous years, did not appear to meet any specific set point, with conditions regularly fluctuating between 60-70%, and creeping up above 70% in the late summer. Though the RH did not stay high enough for a long enough period to lead to likely mold germination, the environmental conditions still placed objects at risk of mechanical damage due to the consistently high RHs.

Gallery, RH Graph - 2018. Upper limit line is at 70% RH.

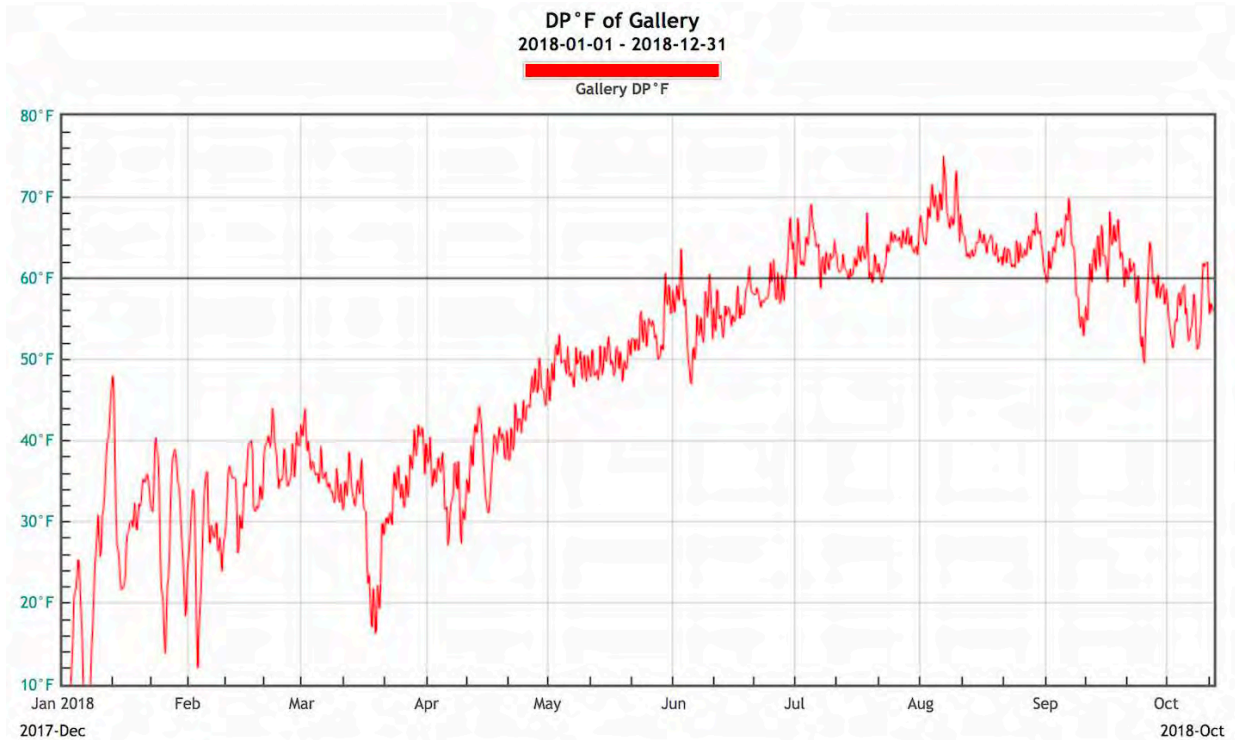
Without loggers in the mechanical system, it is difficult to specifically identify what the dehumidifier operation was; the pattern of the indoor dew point indicates that it is likely tracking fairly closely with outdoor conditions (there is no outdoor data available for this past summer to compare with). The originally discussed 72F/55% summer set points would have resulted in a 55F dew point; even if set points were raised to 75F/60%, the system should have maintained something close to a 60F dew point.

Gallery, DP Graph - 2018. The limit line is set at a 60F dew point, which would correspond to a 75F/60% RH condition.

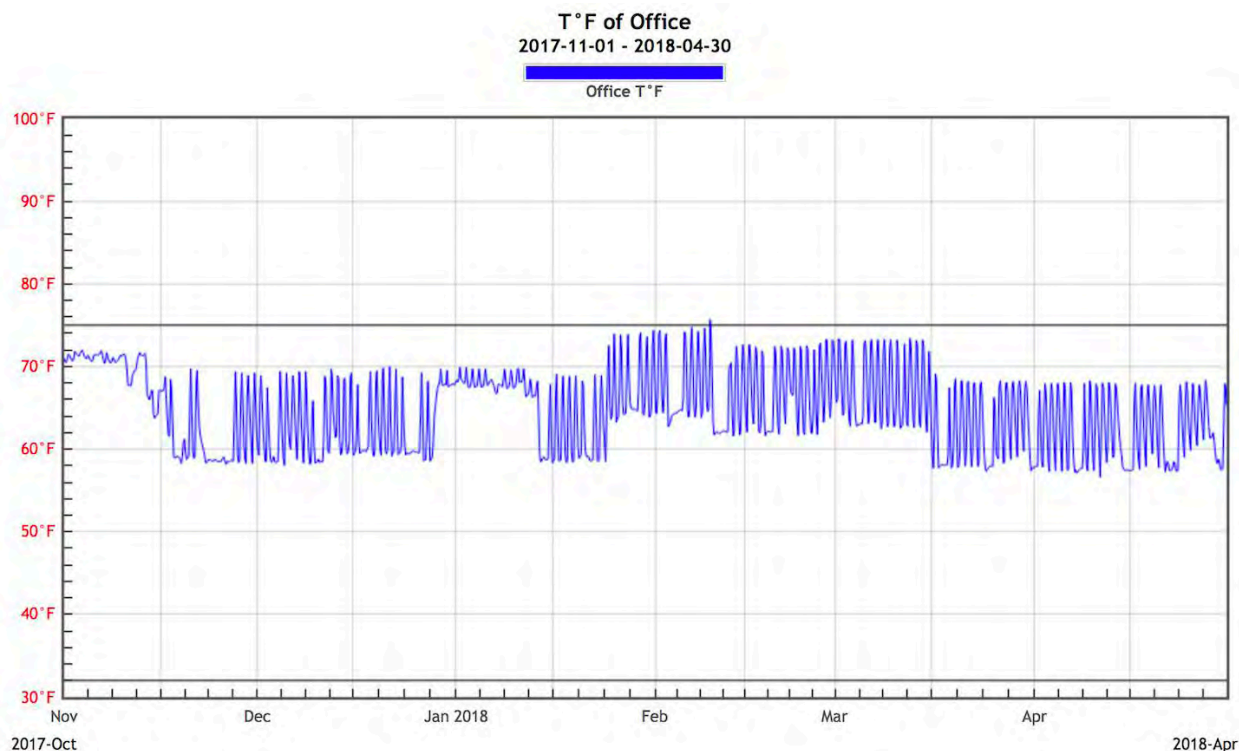
The winter of 2017-2018 was the first winter on the new systems, with the old propane heaters removed. The temperature plot and pattern of operation seem very close to the final desired conditions, with occupied temperatures between 68-72F (there was a set point change from 72-68F midseason), and unoccupied conditions between 58-62F. While active heating was provided during occupied hours, the temperature was allowed to drift cooler during unoccupied hours until it hit the low-limit temperature, where it maintained until the occupied mode kicked in. RH, which is not part of the winter control, typically ranged between 20-40%, spending roughly a quarter of the season below 30%.

Office, T Graph - Winter 2017-2018. Note daily occupied/unoccupied control with weekends. Warmer temperatures in early January were in response to cold outdoor conditions.
